## 01-06/07 CLASSIC GM PICKUP CENTER CONSOLE LID REPAIR KIT

SKU 1449-0003DGY, 1449-0003GY, 1449-0003TN

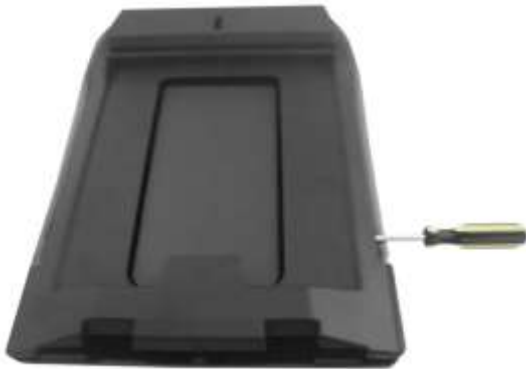
PICTURE 1

1. (OPTIONAL) Remove center console from vehicle.
2. Using a flathead screwdriver, or equivalent, pry loose the inner plastic panel from your console lid (PICTURE 1).
3. Push or pull the hinge rod out to remove the lid from the center console (PICTURE 2).

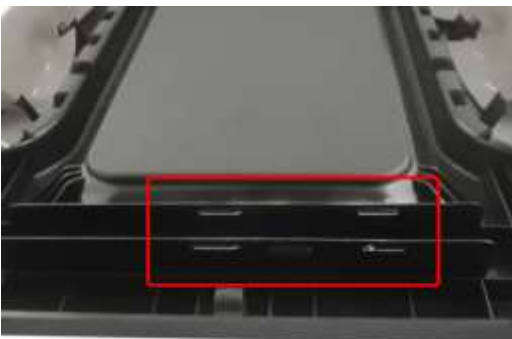
PICTURE 3

4. In your new console lid secure the metal bracket with the holes as shown (PICTURE 3).
5. Install the crooked end of the springs into the metal bracket (PICTURE 4).
6. Install the new console lid to your center console by lining up the hinges and springs then insert the hinge rod to connect both pieces (PICTURE 5).
